Manhole Inspection Summary

Manhole # S25GG1077MH

Location Address: **1020 41ST ST**

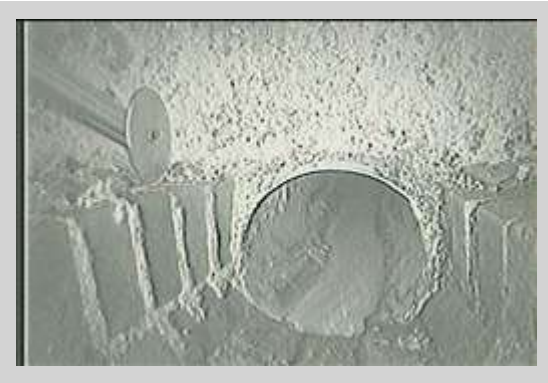
10 in. Circular Gravity Sewer Pipe Out @ 12 O'Clock

Pipe Material: **PVC** ☐ Pipe Lined

Invert Depth: **14.61** (ft.) Flow Characteristics: **Slow**

Deposits: ☒ None ☐ Mud ☐ Sludge ☐ Debris ☐ Grease

Infiltration: **None** Pipe Seal Cond: **Unknown**

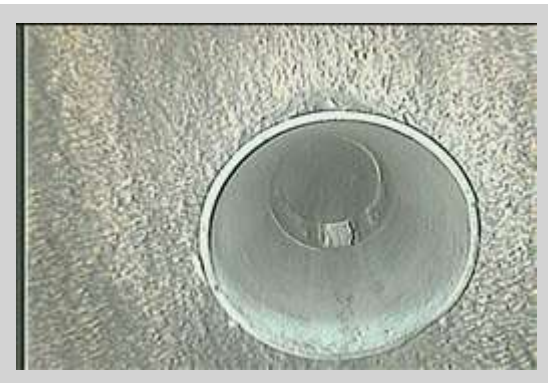
8 in. Circular Gravity Sewer Pipe In @ 3 O'Clock

Pipe Material: **PVC** ☐ Pipe Lined

Invert Depth: **5.32** (ft.) Flow Characteristics: **Slow**

Deposits: ☒ None ☐ Mud ☐ Sludge ☐ Debris ☐ Grease

Infiltration: **None** Pipe Seal Cond: **Unknown**

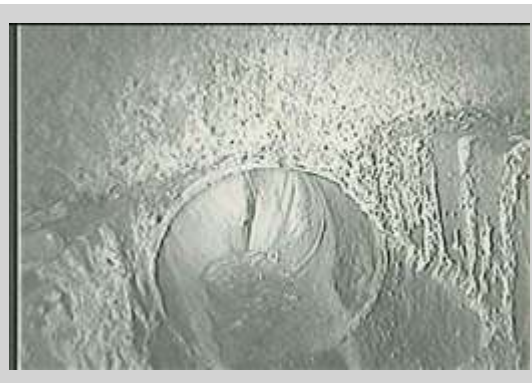
Drop In @ 3 O'Clock

Drop: **Outside** Rod and Bar

Angled: **Yes** Reading: **13.41** (ft.)

Drop Condition: **Open**
